**1973 JC Boats 31**  
***"JC No 1 Plug"***

# **Report of Marine Survey**

**1973 JC Boats 31**

December 09, 2015

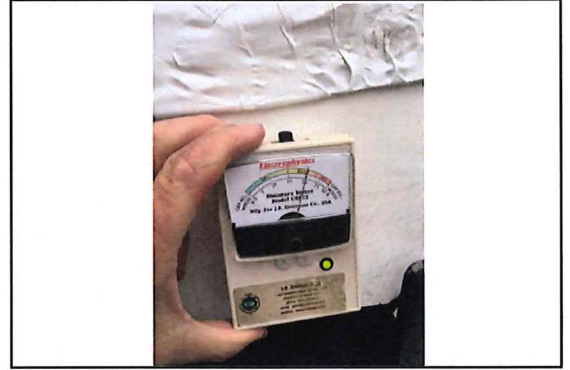
120915JC 012.JPG

The moisture testing and percussion sounding was performed and some areas of elevated moisture indications were sighted, the percussion soundings revealed a few areas of voids (delamination) under the outer FRP laminates.

**The moisture testing and percussion sounding was performed and some areas of elevated moisture indications were sighted, the percussion soundings revealed a few areas of voids (delamination) under the outer FRP laminates.**

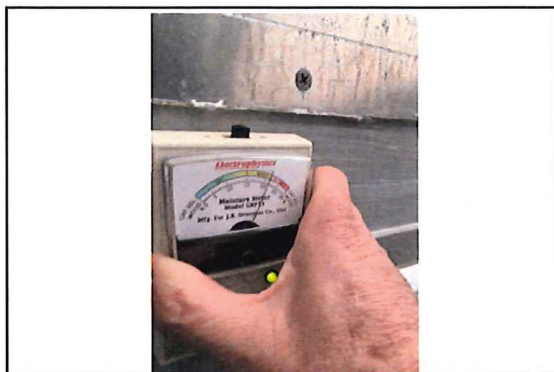
120915JC 023.JPG

Moisture testing of the bulkheads revealed no anomalies, the forward bulkhead had one area of elevated moisture indications over the access hatch.

**Moisture testing of the bulkheads revealed no anomalies, the forward bulkhead had one area of elevated moisture indications over the access hatch.**

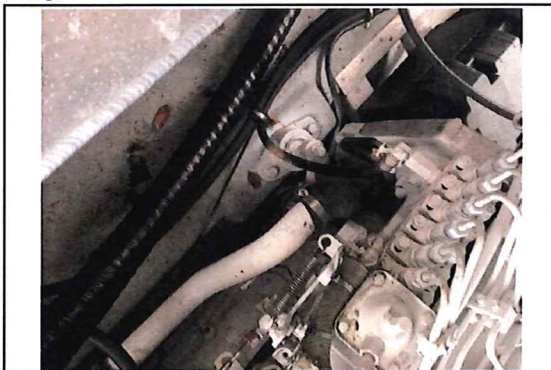
120915JC 066.JPG

\* **CONDITION AND DEFICIENCIES:** [C5] The raw water pump outlet hose to the after cooler was sighted to be fastened with only one clamp.

*Further investigate and repair as necessary. The hose should be fastened with two clamps if the pump fitting allows or a single clamp of HD type with a wider band.*

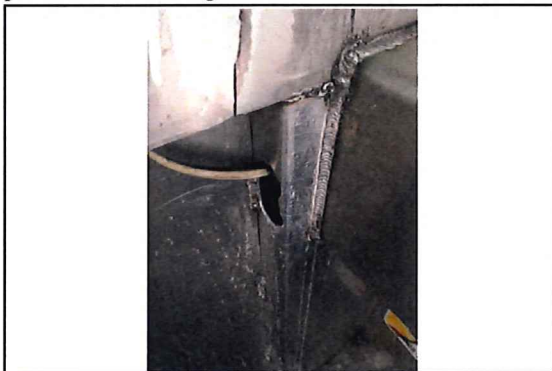
120915JC 072.JPG

\* ROUTING/SUPPORT: [C8] The running lights' wires were sighted to be channeled thru the aluminum frame and were sighted not to be protected from chafing
