Re: National Liability & Fire Insurance Company
Insured: Nathan Carman
Insured Yacht: 1974 JC 31' Cruiser, HIN MSZMT502J303
Date of Loss: 9/18/2016
Claim No. 1607671
Policy No. 3985989-15

Opinion

Re: 1973 JC31 prototype, ex-*"Chicken Pox"*
Insured: Nathan Carman
D/L: 09/18/2016
T/L: Sinking
Claim: 1607671

Preliminary Report

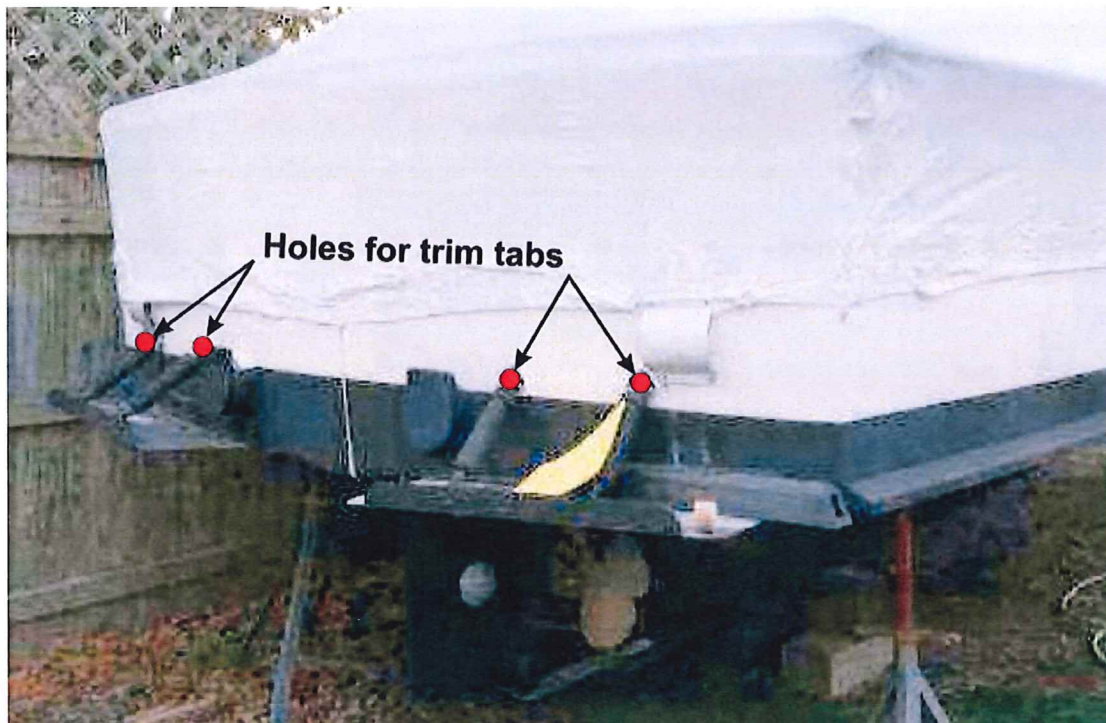
The subject vessel sank apparently somewhere north of the Block Canyon fishing area on September 18, 2016. On September 17, the trim tabs were removed by Mr. Carman. The removal of the trim tab mounting brackets left exposed holes in the transom that Mr. Carman attempted to repair.

Figure 1 shows the location of the trim tab support brackets that were removed. The holes were located behind the brackets. Figure 2 shows the same locations with the boat underway in a planing condition.

Figure 1. Location of trim tab transom holes
[exhibit 4 from Nathan Carman statement]

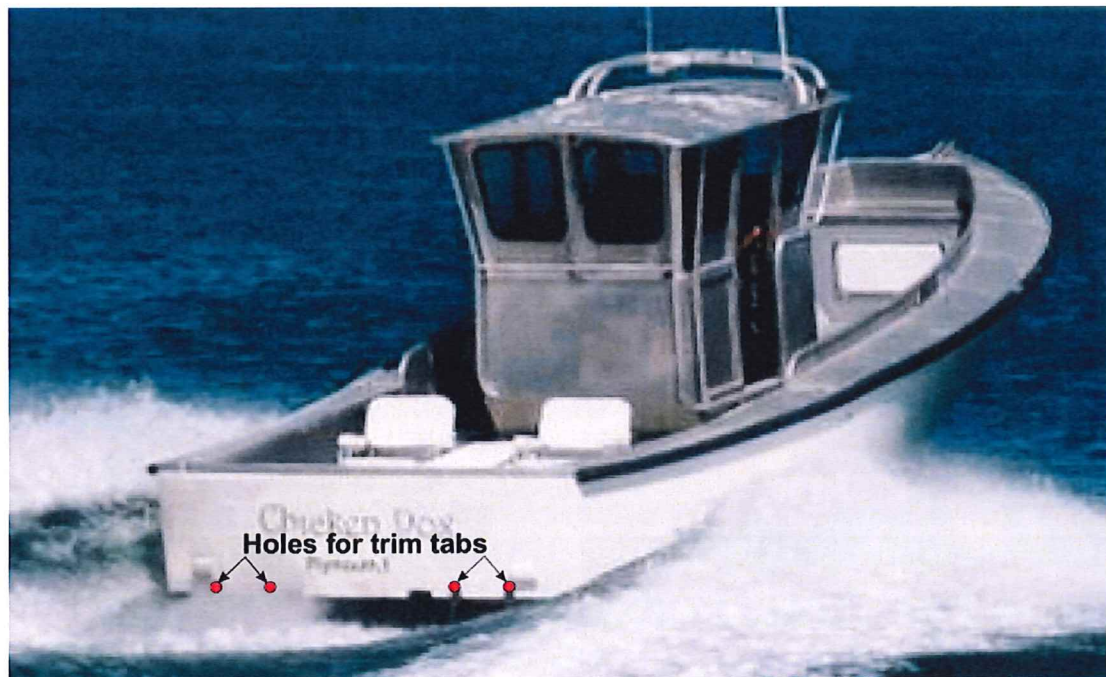
Figure 2. Trim tab hole location with boat in planing condition
[photograph by Brian Woods <http://downeastboatforum.com/free-classifieds-for-downeast-boats-marine-equipment-fishing-tackle-for-sale-or-wanted-/11236-31-jc-custom-aluminum-walkaround-pilothouse.html>]

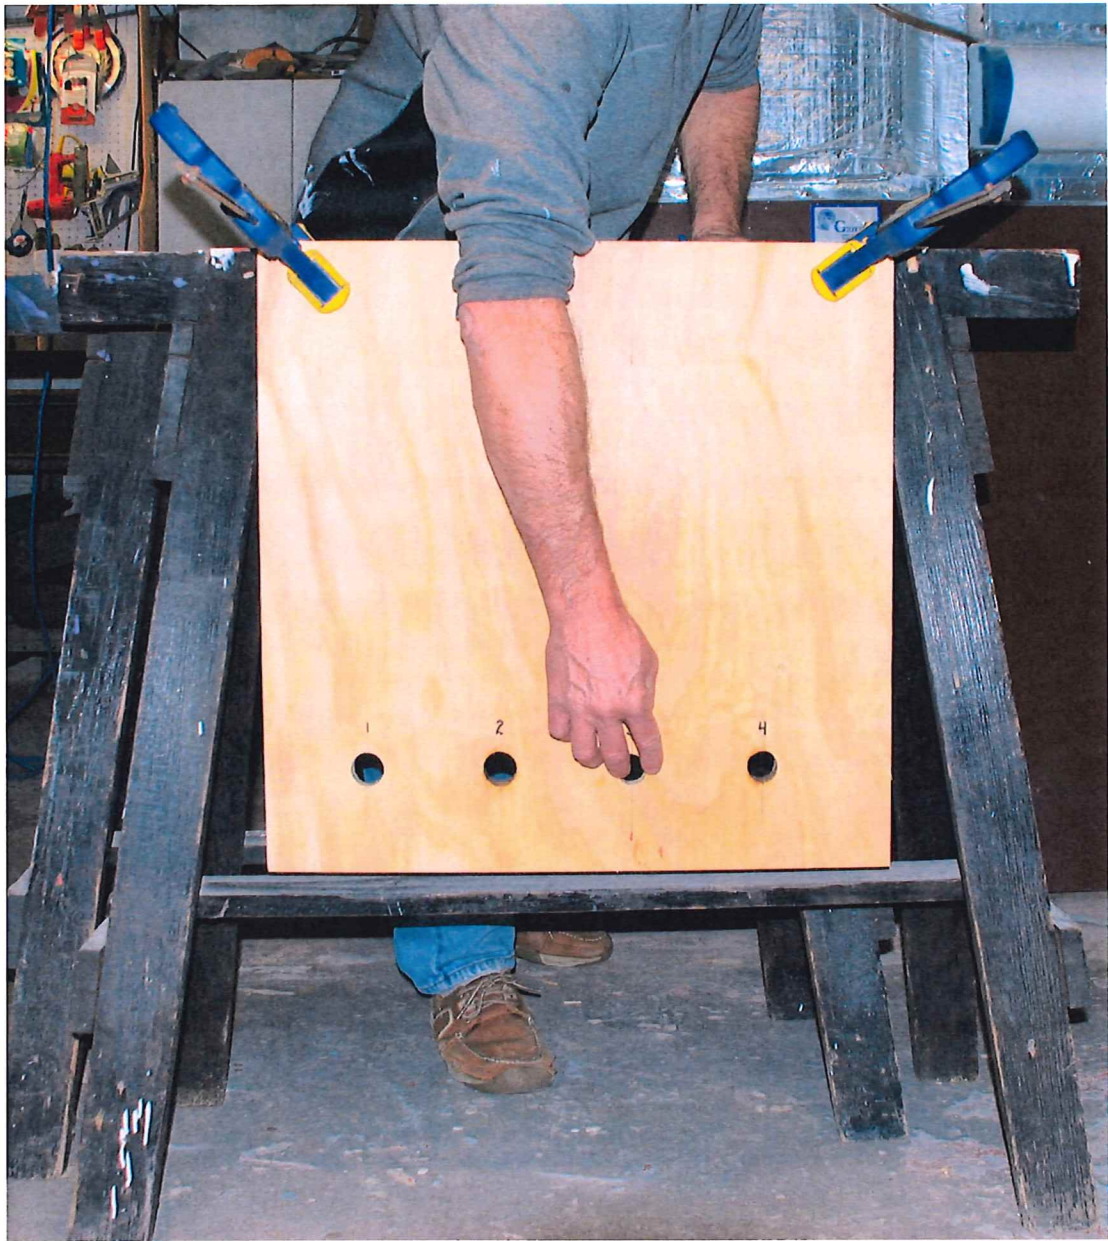
The same procedure that Mr. Carman outlined was used to test the efficacy of using the epoxy putty stick to repair 1.125 and 1.25 inch holes in 3/4 inch plywood. Figure 5 shows the plywood oriented to simulate an over the transom repair attempt. Figure 6 shows the repair attempt in progress.

Figure 5. Orientation of plywood for investigation

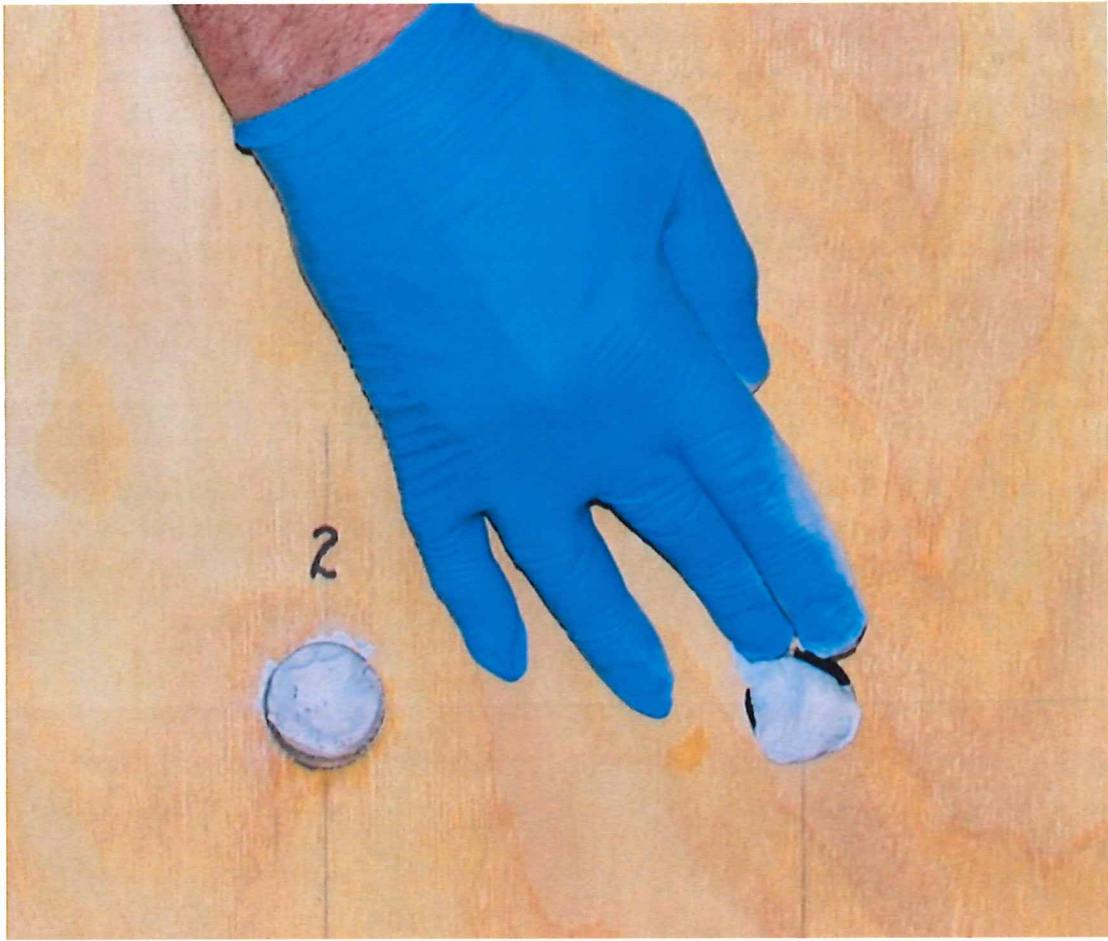
Figure 6. Attempted repair procedure in progress

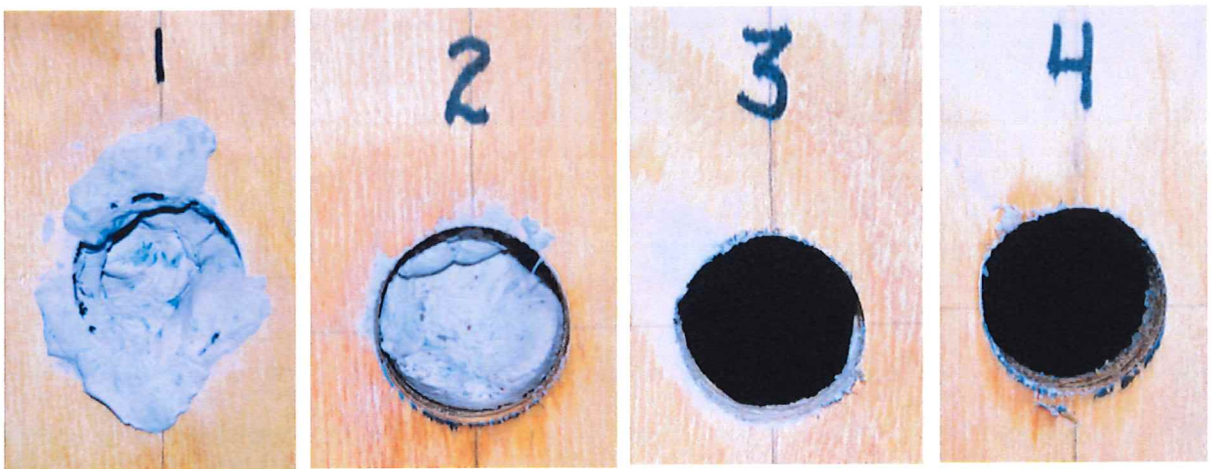
Figure 7 shows the results of the attempted repair. For holes 3 and 4, the putty mixture fell through the back of the plywood as it was being forced into the hole. After a 2-hour cure time, the putty mixture in hole 2 was easily dislodged with minimal force.

The surface of the repair could be smoothed to create a flush appearance on the outside but there would be minimal contact between the putty and the curved surface of the holes. The resulting plug of putty would not be able to adequately resist hydrostatic or other forces incurred during vessel operation. Indeed, this was the case with hole #2.

Figure 7. Results immediately after attempted repair

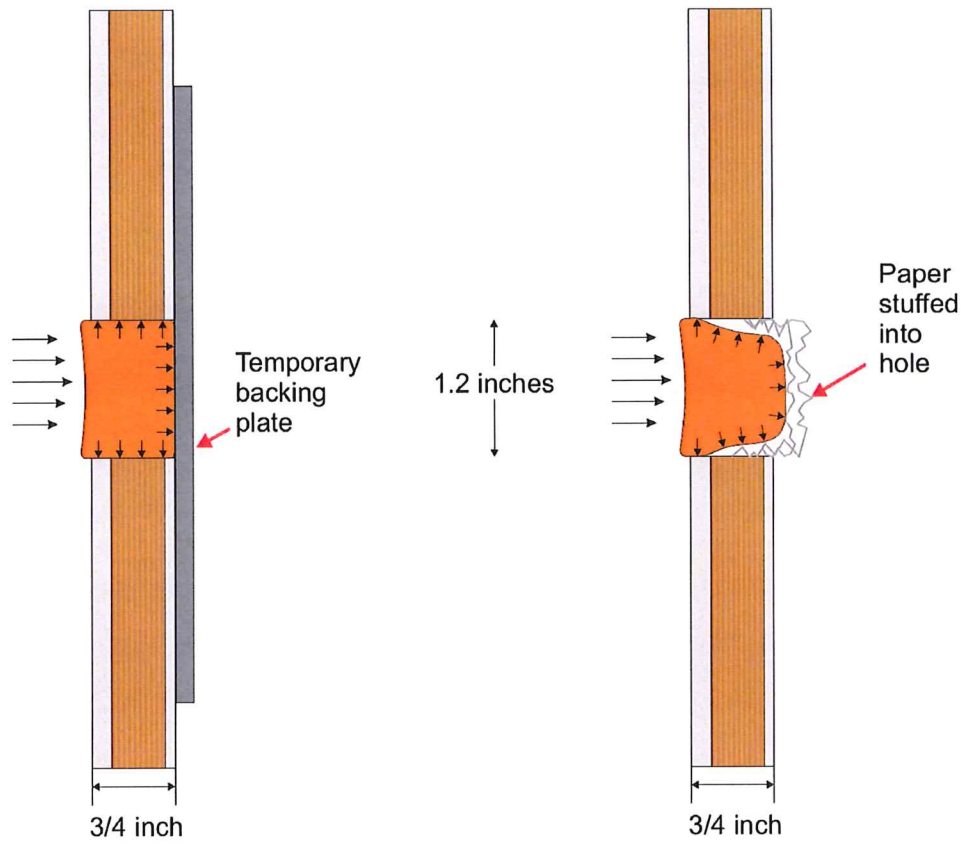
The proper use of that product for holes this large would require a temporary backing plate, as shown in the left side of Figure 8. Figure 8 also shows what would happen if paper towels were used in lieu of a backing plate. There would be no resistance to keep the putty from being pushed through the hole without the necessary spreading required to ensure contact with the hole walls. This was confirmed when the putty fell out of the back of holes #3 and #4.

Figure 8. Illustration showing anticipated results for repair using temporary backing plate versus paper towel

If the interior of the transom was truly inaccessible at this location, a preferable approach would have been to create a tight fitting plug that could be bonded into the hole with epoxy. A conventional fiberglass patch over the outside would complete such a repair. If one or more of the transom holes were not repaired correctly, even a 1-foot following sea would result in a substantial amount of water entering the bilge over a five-hour period.
