BoatU.S. Marine Insurance Program Claims
Administrative Office
880 South Pickett Street
Alexandria, VA 22304
24 Hr. Claims: 800 937-1937
Fax: 703 461-2843
Direct Dial: 800 267 8382

Re: National Liability & Fire Insurance Company
Insured: Nathan Carman
Insured Yacht: 1974 JC 31' Cruiser, HIN MSZMT502J303
Date of Loss: 9/18/2016
Claim No. 1607671
Policy No. 3985989-15

Opinion

Re: 1973 JC31 prototype, ex-*"Chicken Pox"*
Insured: Nathan Carman
D/L: 09/18/2016
T/L: Sinking
Claim: 1607671

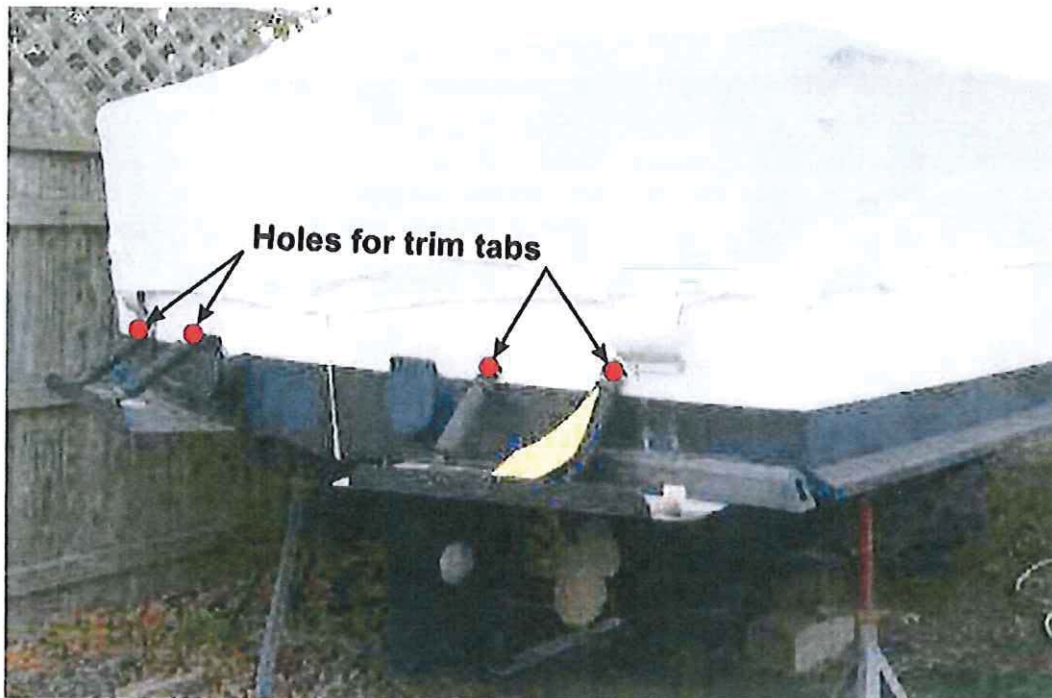
Figure 1. Location of trim tab transom holes
[exhibit 4 from Nathan Carman statement]

The subject vessel sank apparently somewhere north of the Block Canyon fishing area on September 18, 2016. On September 17, the trim tabs were removed by Mr. Carman. The removal of the trim tab mounting brackets left exposed holes in the transom that Mr. Carman attempted to repair.

Figure 1 shows the location of the trim tab support brackets that were removed. The holes were located behind the brackets. Figure 2 shows the same locations with the boat underway in a planing condition.

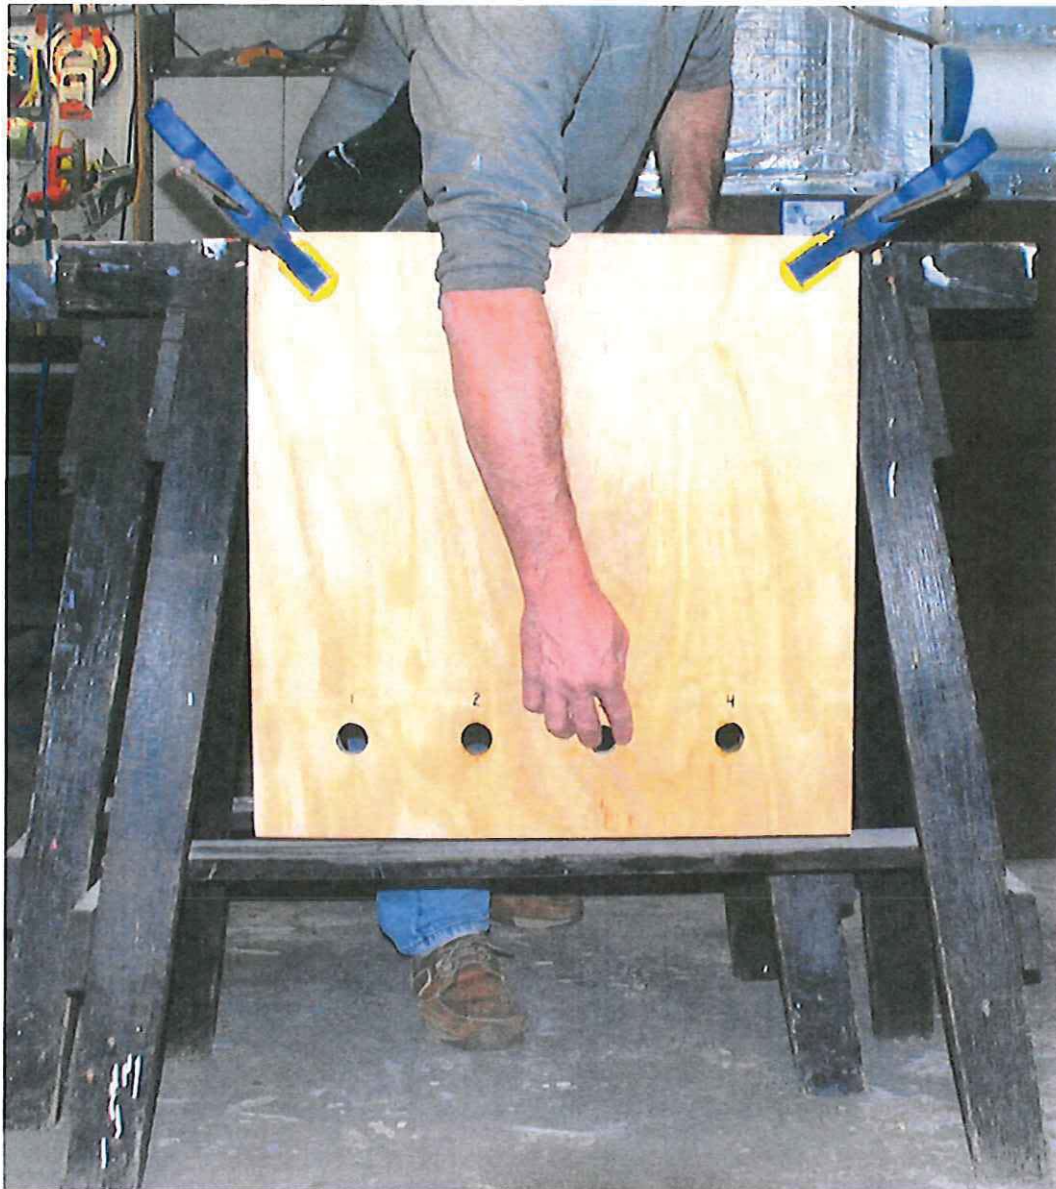
Figure 5. Orientation of plywood for investigation

The same procedure that Mr. Carman outlined was used to test the efficacy of using the epoxy putty stick to repair 1.125 and 1.25 inch holes in $\frac{3}{4}$ inch plywood. Figure 5 shows the plywood oriented to simulate an over the transom repair attempt. Figure 6 shows the repair attempt in progress.

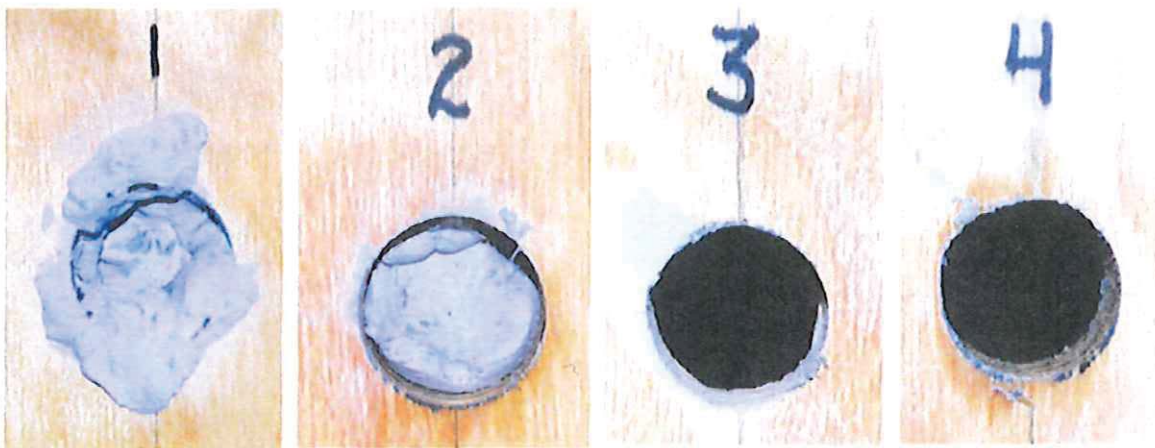
Figure 7. Results immediately after attempted repair

Figure 7 shows the results of the attempted repair. For holes 3 and 4, the putty mixture fell through the back of the plywood as it was being forced into the hole. After a 2-hour cure time, the putty mixture in hole 2 was easily dislodged with minimal force.

It was not possible to achieve a satisfactory repair using the epoxy putty stick in the manner outlined in Mr. Carman's statement. This was confirmed by testing the attempted repair procedure described in Mr. Carman's statement.

The surface of the repair could be smoothed to create a flush appearance on the outside but there would be minimal contact between the putty and the curved surface of the holes. The resulting plug of putty would not be able to adequately resist hydrostatic or other forces incurred during vessel operation. Indeed, this was the case with hole #2.

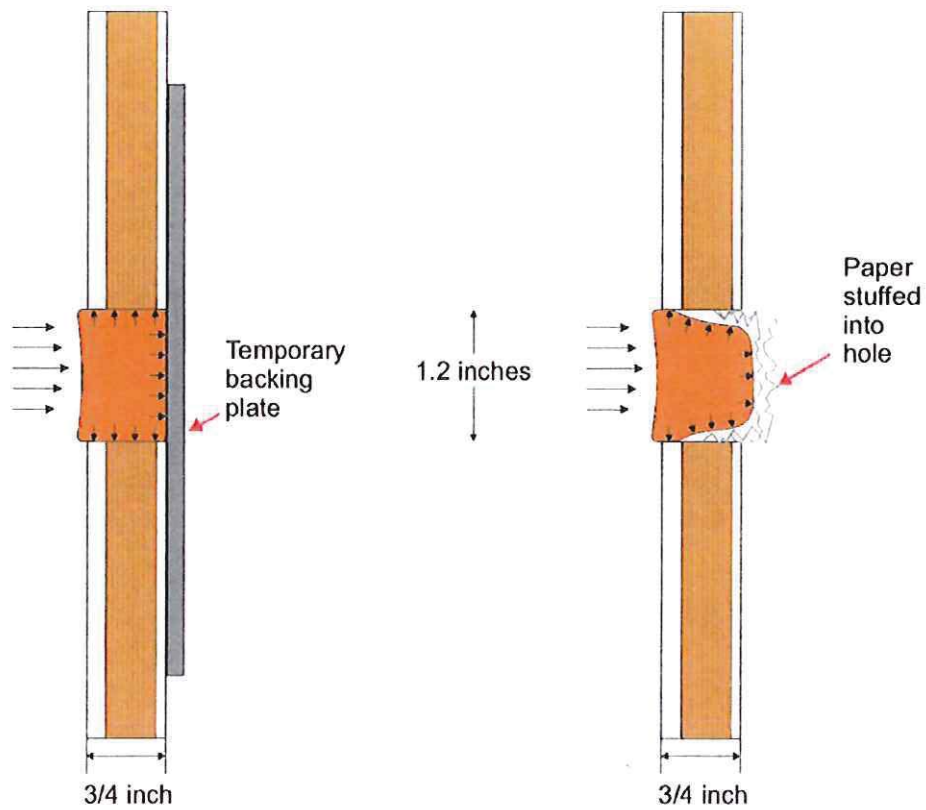
Figure 8. Illustration showing anticipated results for repair using temporary backing plate versus paper towel

The proper use of that product for holes this large would require a temporary backing plate, as shown in the left side of Figure 8. Figure 8 also shows what would happen if paper towels were used in lieu of a backing plate. There would be no resistance to keep the putty from being pushed through the hole without the necessary spreading required to ensure contact with the hole walls. This was confirmed when the putty fell out of the back of holes #3 and #4.

If the interior of the transom was truly inaccessible at this location, a preferable approach would have been to create a tight fitting plug that could be bonded into the hole with epoxy. A conventional fiberglass patch over the outside would complete such a repair. If one or more of the transom holes were not repaired correctly, even a 1-foot following sea would result in a substantial amount of water entering the bilge over a five-hour period.
