DEFENDANT'S
EXHIBIT
D-63

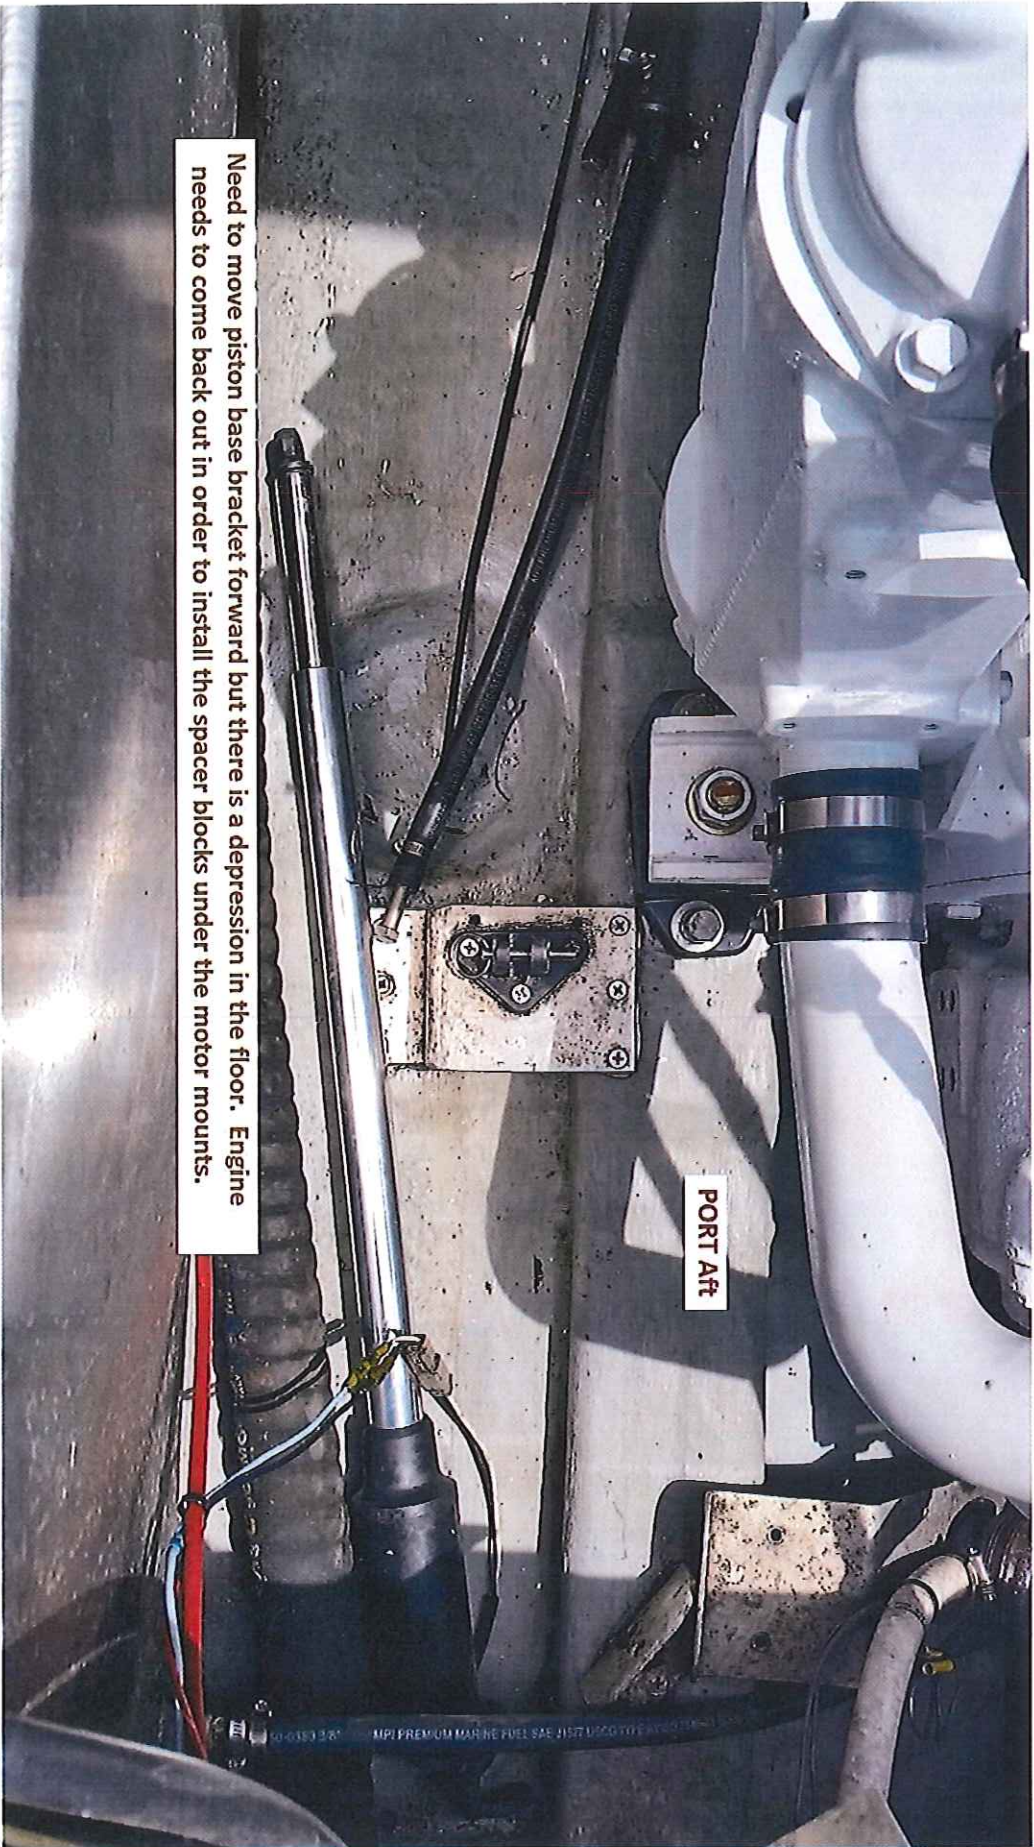
Need to move piston base bracket forward but there is a depression in the floor. Engine needs to come back out in order to install the spacer blocks under the motor mounts.
