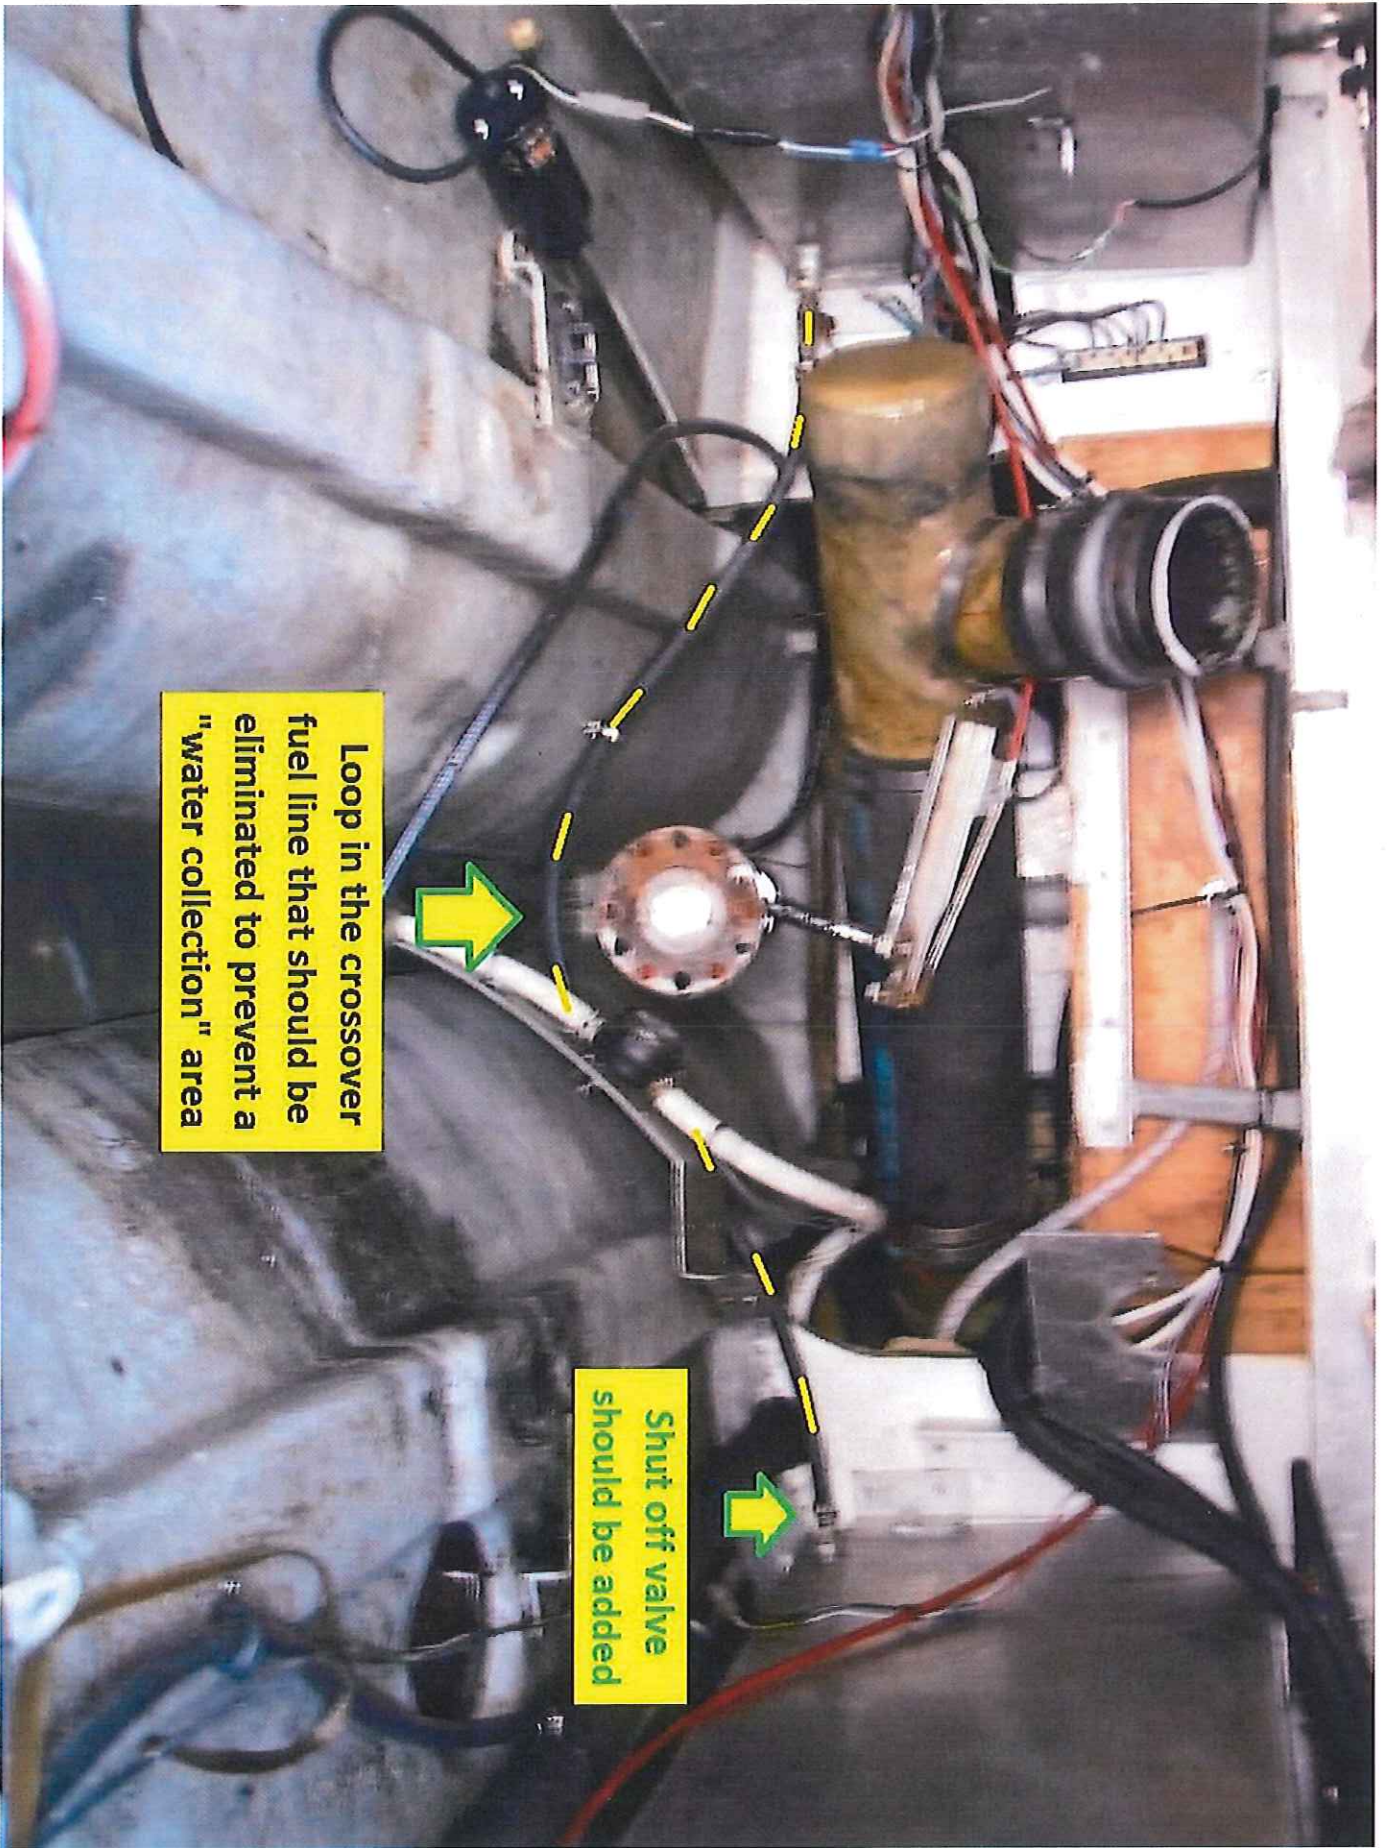
Loop in the crossover fuel line that should be eliminated to prevent a "water collection" area

Shut off valve should be added

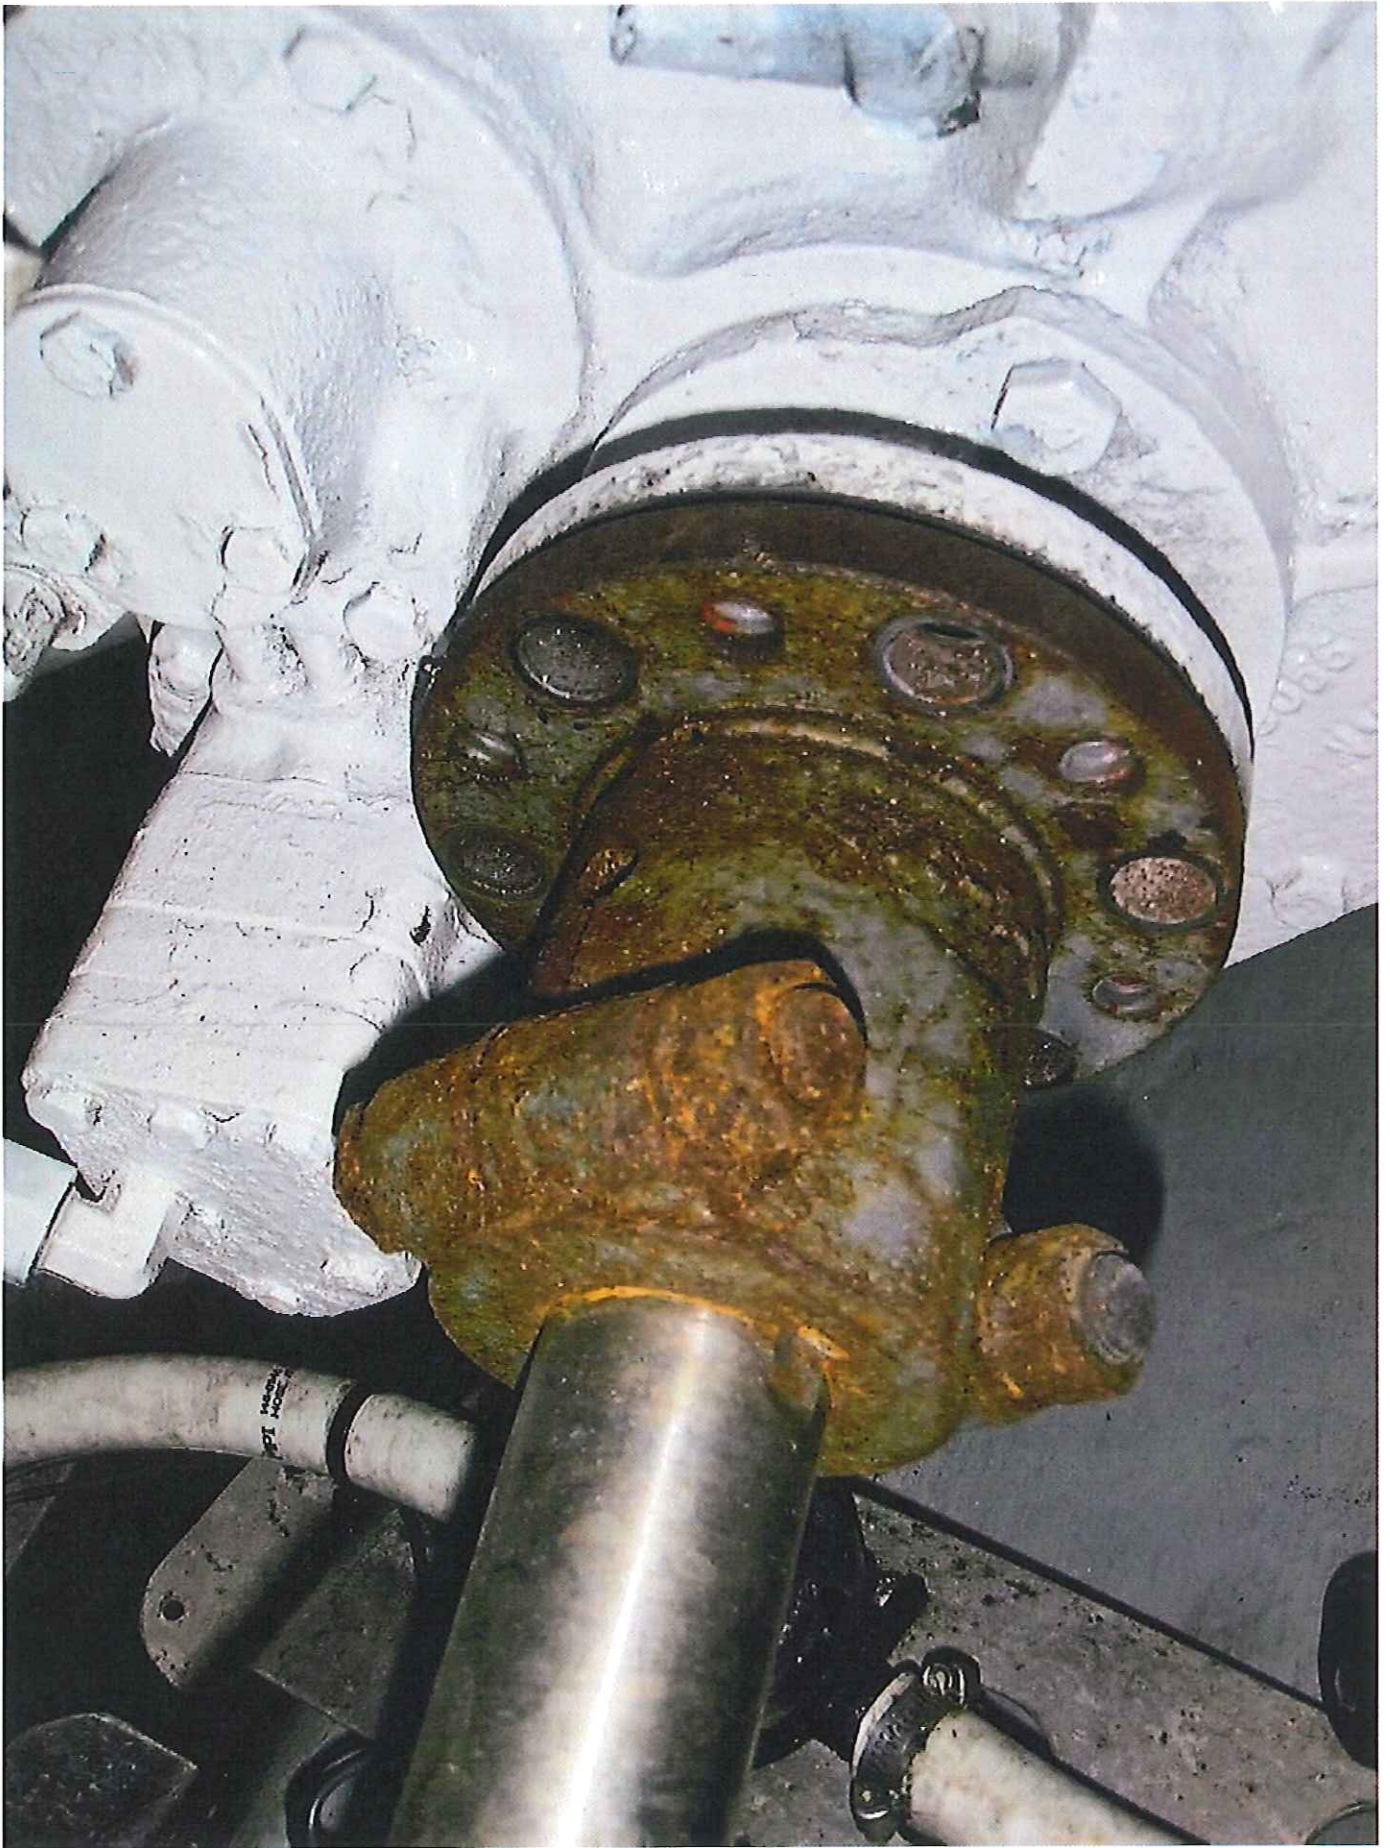
PORT tank

NO shut-off valve on the PORT fuel tank  
(see ADAC H33.14.2)

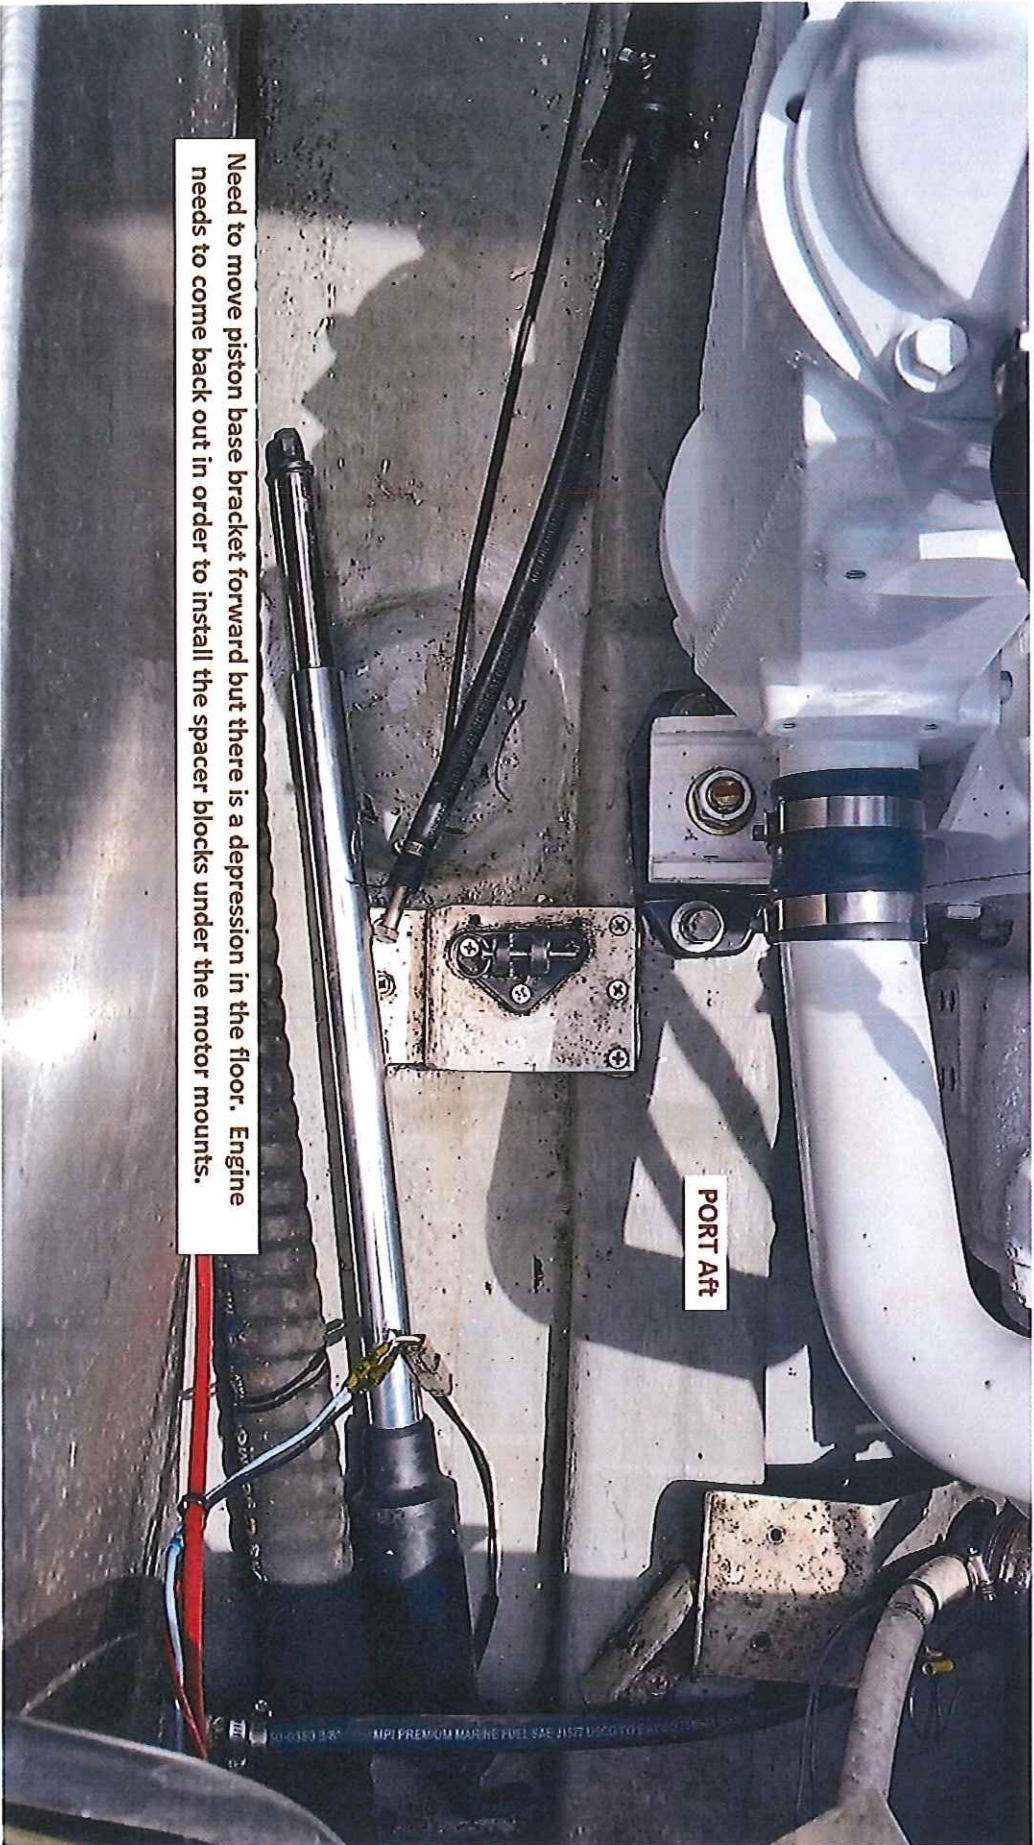
PORT Aft

Need to move piston base bracket forward but there is a depression in the floor. Engine needs to come back out in order to install the spacer blocks under the motor mounts.
