**1973 JC Boats 31**  
***"JC No 1 Plug"***

# **Report of Marine Survey**

**1973 JC Boats 31**

December 09, 2015

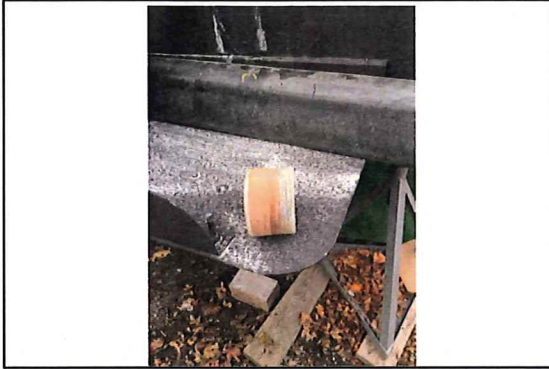
120915JC 003.JPG

**KEEL EXTERNAL:** Reported to be FRP covered mahogany constructed wet flood type, down east design with skeg supported rudder. Limited access precluded a complete inspection. Percussion sounding as well as moisture testing was performed, (the vessel bottom was finished with anti fouling paint, paints will sometimes "store" moisture in the area between the hull and paint surfaces giving false moisture indications as well as the owner indicated that the bottom had been barrier coated) some elevated moisture indications were sighted and percussion sounding indicated areas of FRP issues and were noted. A sample of the hull construction schedule was offered by the owner as a plug removed for a thru hull installation, the core material appear dry with adequate FRP laminates for hull strength. (see photo)

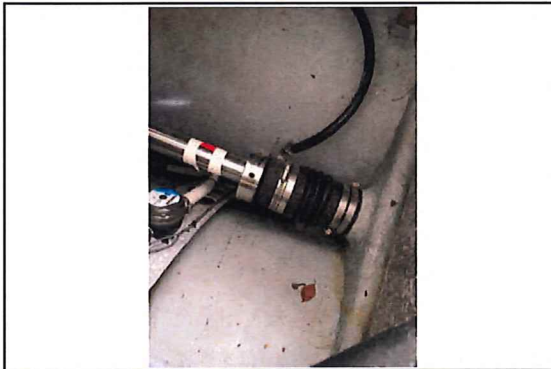
120915JC 043.JPG

\* **CONDITION AND DEFICIENCIES:** [C5] The raw water pump outlet hose to the after cooler was sighted to be fastened with only one clamp.

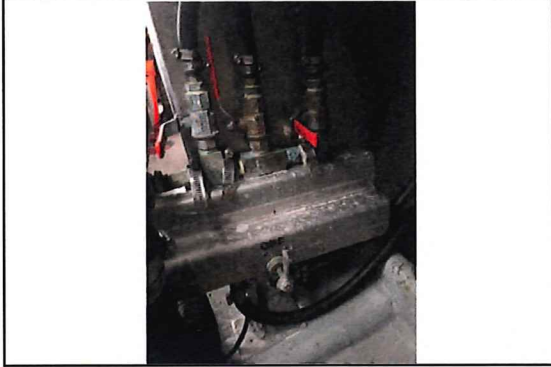
120915JC 028.JPG

\* **FUEL MANIFOLD VALVES:** [C6] Bronze type valves properly marked, operable, located under the forward hatch port side, appear serviceable.

The fuel transfer valves were not marked as to their functions.

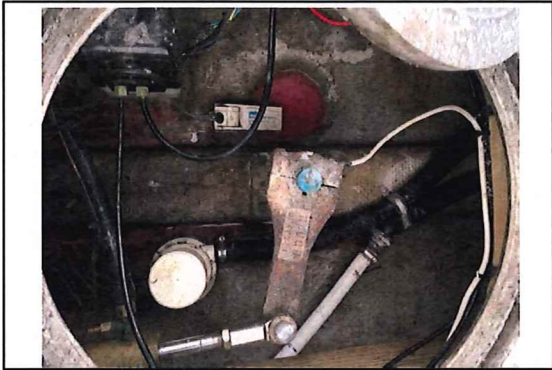
120915JC 056.JPG

**PACKING GLAND:** Bronze hex nut type packing gland. Appeared serviceable. Monitor frequently.

The rudder box gland was sighted to be leaking more than normal, the owner is advised to monitor this issue and after the packing has had time to wet out adjust for normal operation.
