Re: National Liability & Fire Insurance Company
Insured: Nathan Carman
Insured Yacht: 1974 JC 31' Cruiser, HIN MSZMT502J303
Date of Loss: 9/18/2016
Claim No. 1607671
Policy No. 3985989-15

Opinion

Re: 1973 JC31 prototype, ex-*"Chicken Pox"*
Insured: Nathan Carman
D/L: 09/18/2016
T/L: Sinking
Claim: 1607671

Preliminary Report

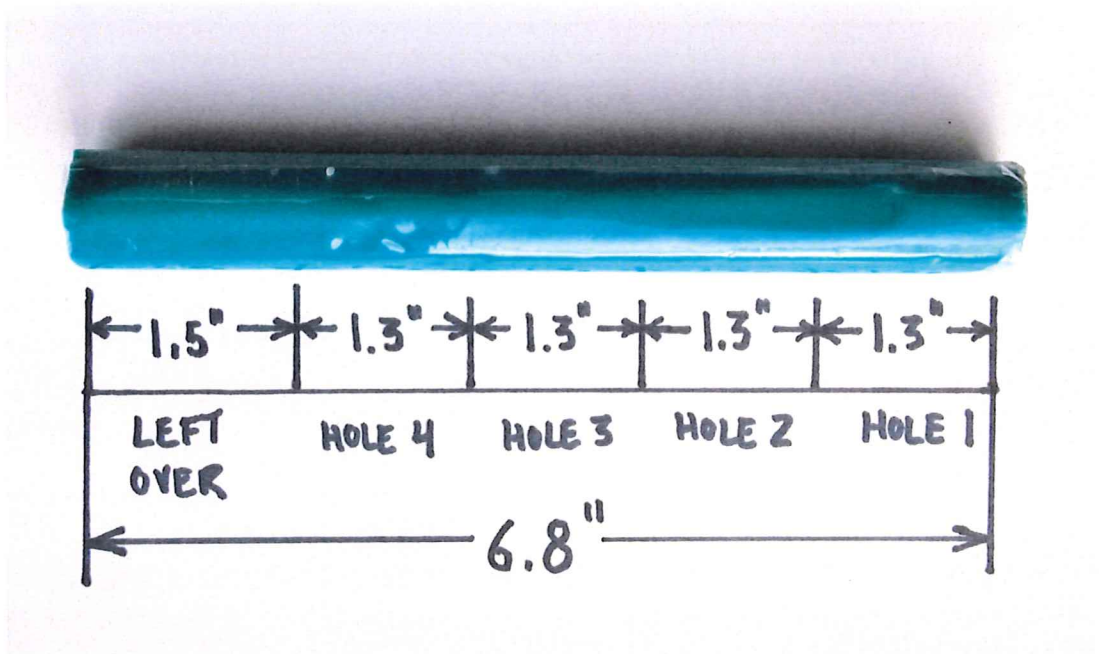
into sections that replicated Mr. Carman's statement, using an average of 1.5 inches as the remaining product amount. Four sections measuring approximately 1.33 inches were cut using a razor blade, as shown in Figure 3. Two 1.25 inch and two 1.125 inch holes were drilled into a piece of 3/4 inch plywood, as shown in Figure 4. An oil and water mixture was rubbed into the curved surfaces of holes 2 and 4.

Figure 3. West Marine Epoxy Putty Stick prior to being cut into sections for investigation

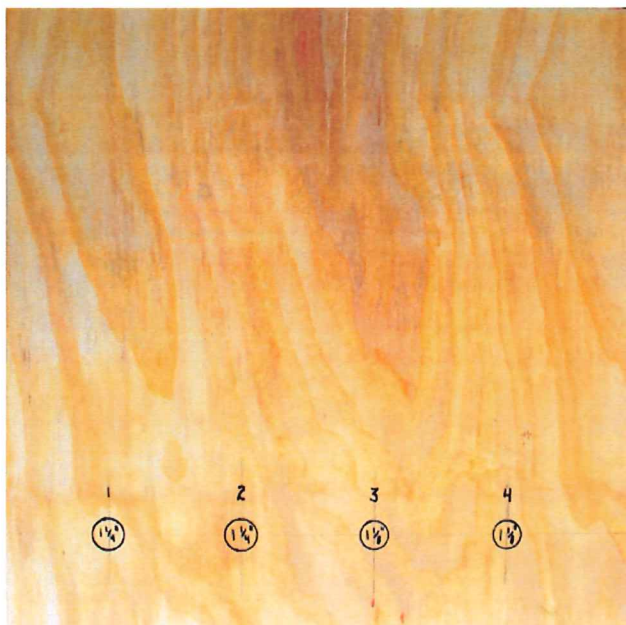
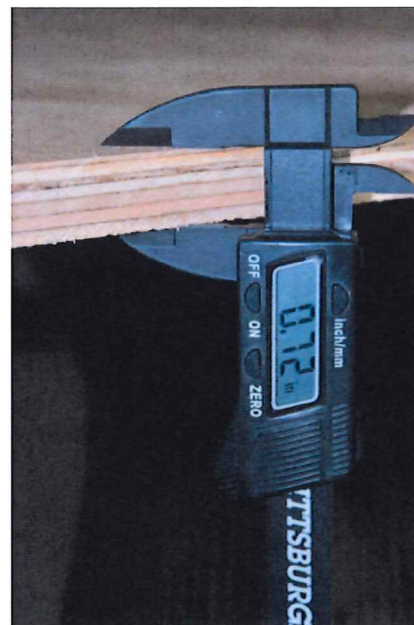
Figure 4. Plywood used for investigation
