BoatU.S. Marine Insurance Program Claims
Administrative Office
880 South Pickett Street
Alexandria, VA 22304
24 Hr. Claims: 800 937-1937
Fax: 703 461-2843
Direct Dial: 800 267 8382

Re: National Liability & Fire Insurance Company
Insured: Nathan Carman
Insured Yacht: 1974 JC 31' Cruiser, HIN MSZMT502J303
Date of Loss: 9/18/2016
Claim No. 1607671
Policy No. 3985989-15

Opinion

Re: 1973 JC31 prototype, ex-*"Chicken Pox"*
Insured: Nathan Carman
D/L: 09/18/2016
T/L: Sinking
Claim: 1607671

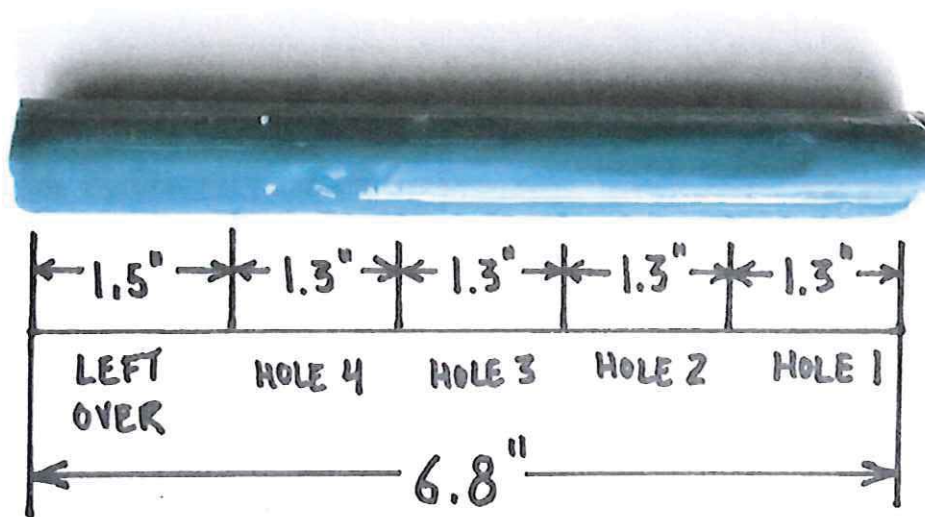
into sections that replicated Mr. Carman's statement, using an average of 1.5 inches as the remaining product amount. Four sections measuring approximately 1.33 inches were cut using a razor blade, as shown in Figure 3. Two 1.25 inch and two 1.125 inch holes were drilled into a piece of $\frac{3}{4}$ inch plywood, as shown in Figure 4. An oil and water mixture was rubbed into the curved surfaces of holes 2 and 4.

Figure 3. West Marine Epoxy Putty Stick prior to being cut into sections for investigation

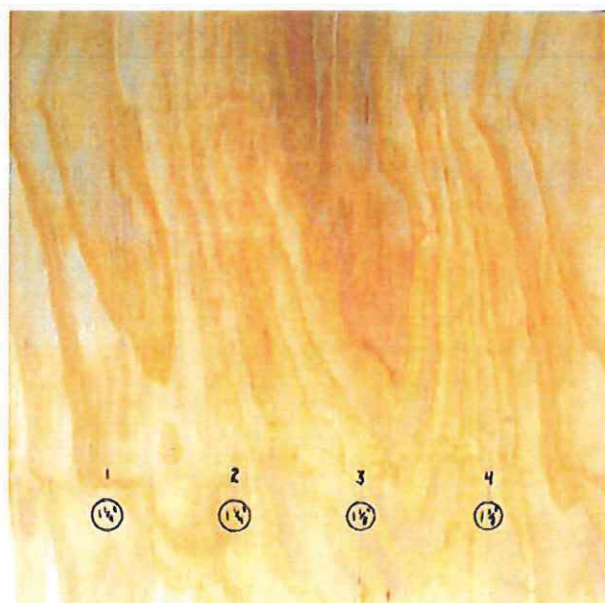
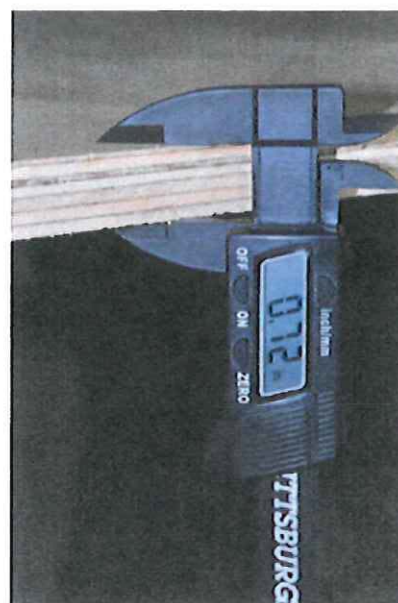
Figure 4. Plywood used for investigation
