DEFENDANT'S
EXHIBIT
D-63

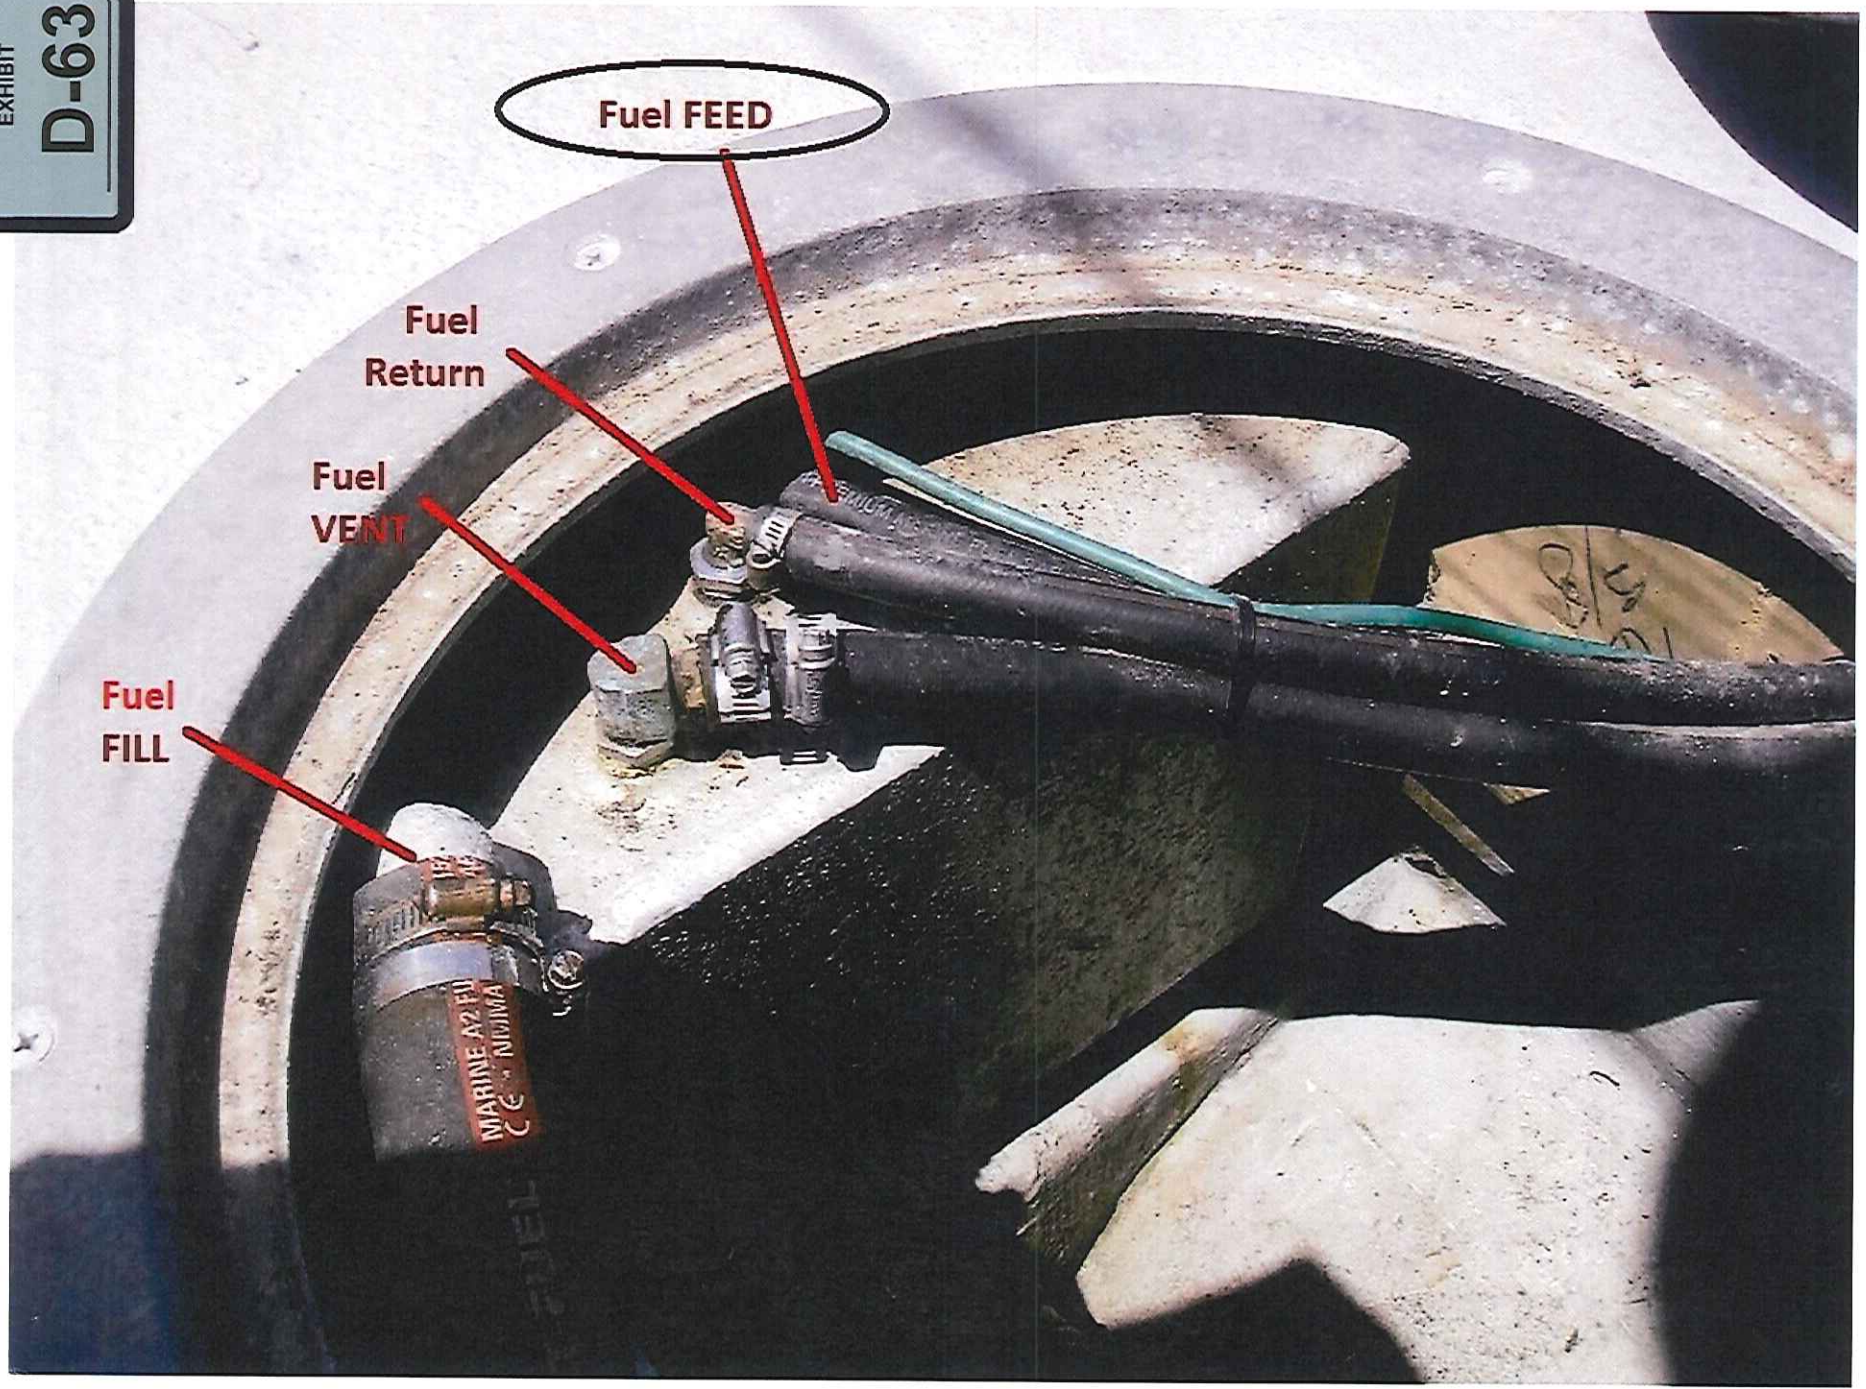
①

**Loop in the crossover
fuel line that should be
eliminated to prevent a
"water collection" area**

**Shut off valve
should be added**

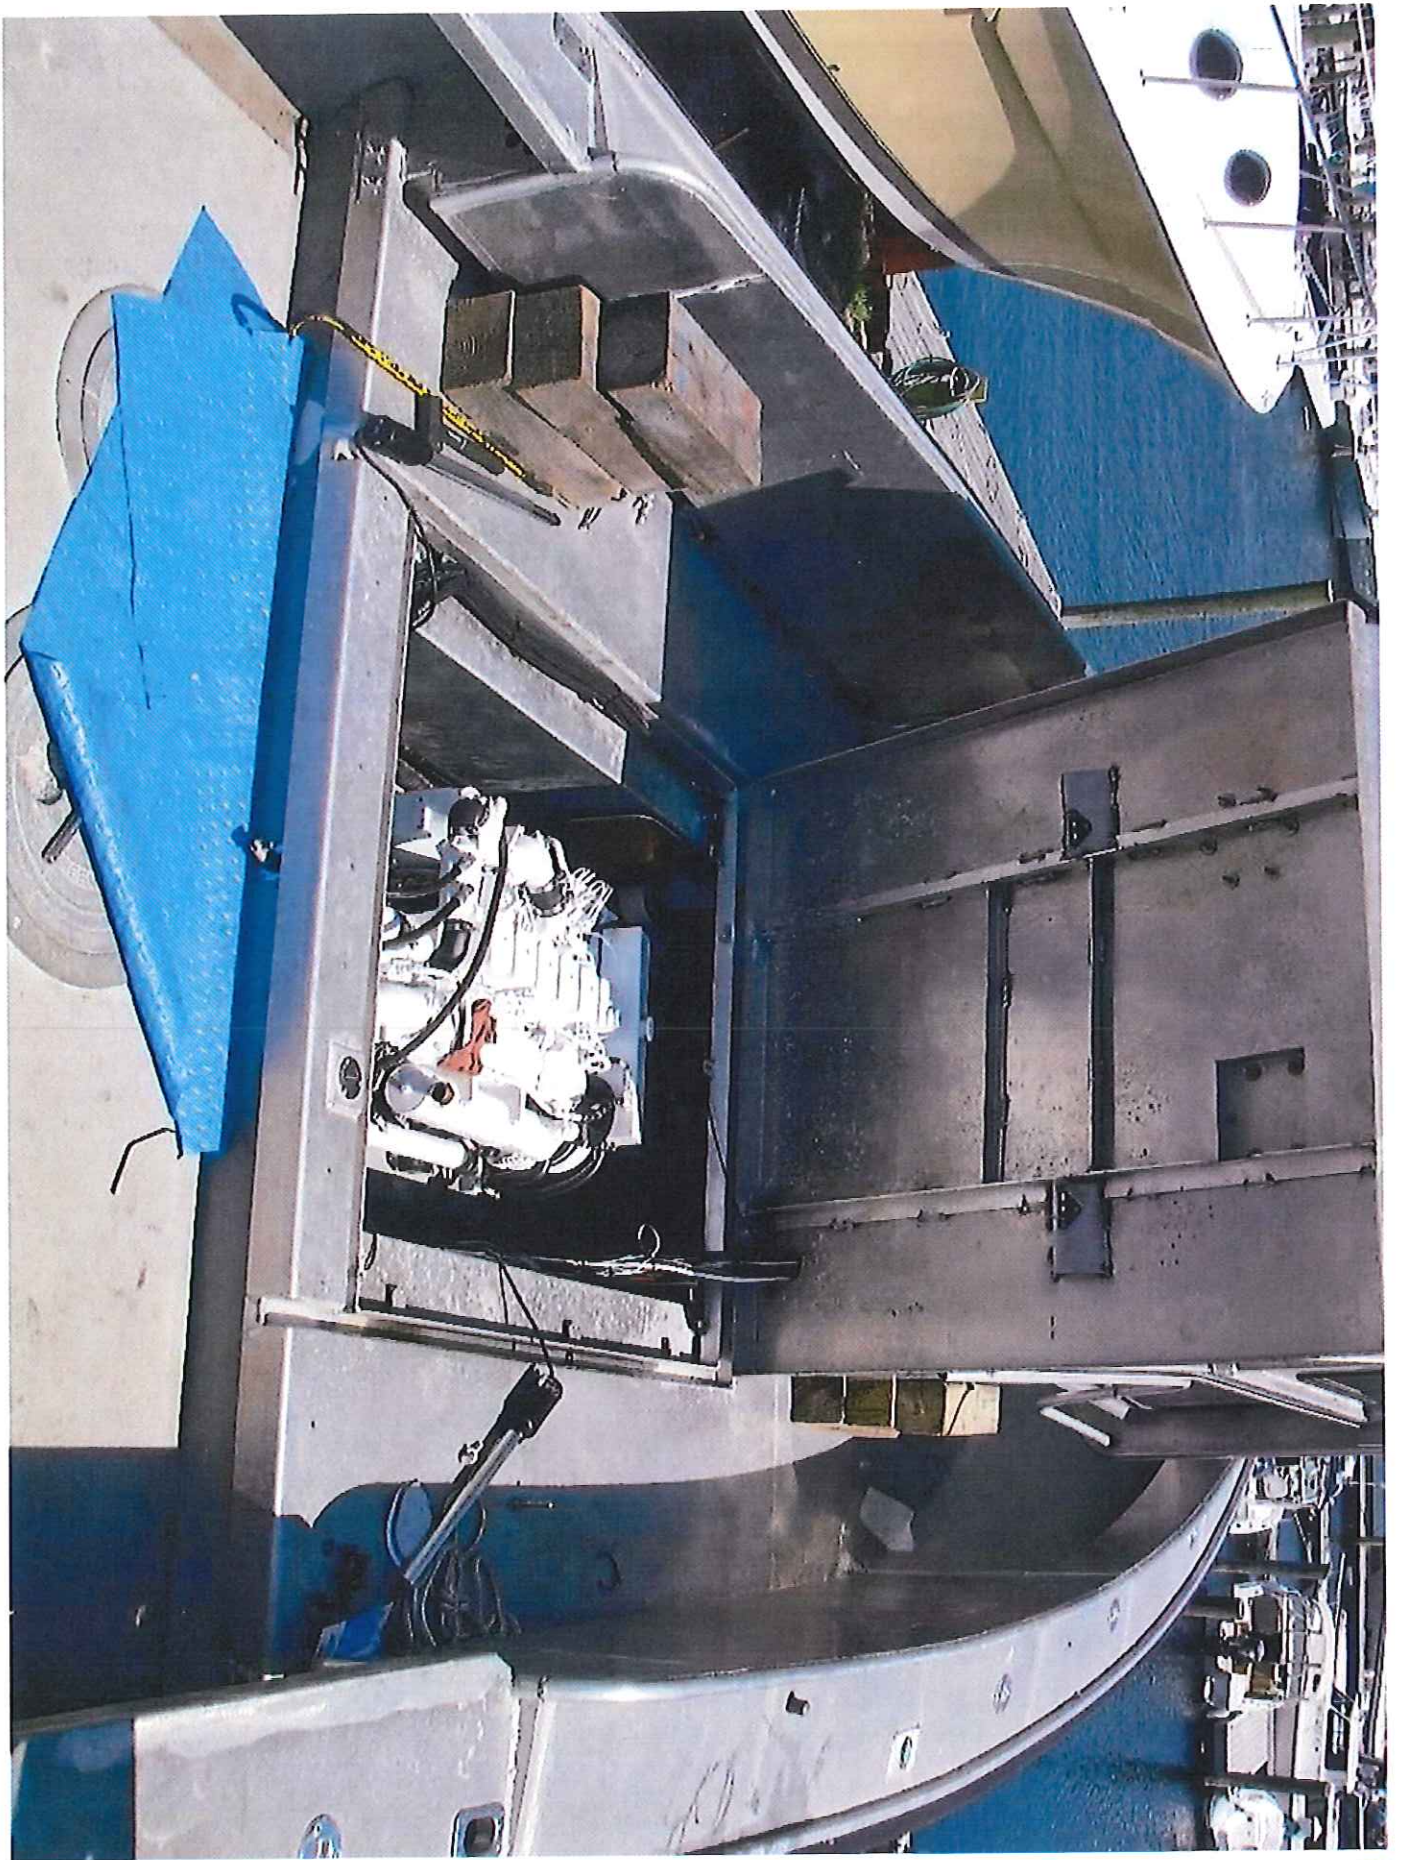
Need to move piston base bracket forward but there is a depression in the floor. Engine needs to come back out in order to install the spacer blocks under the motor mounts.
