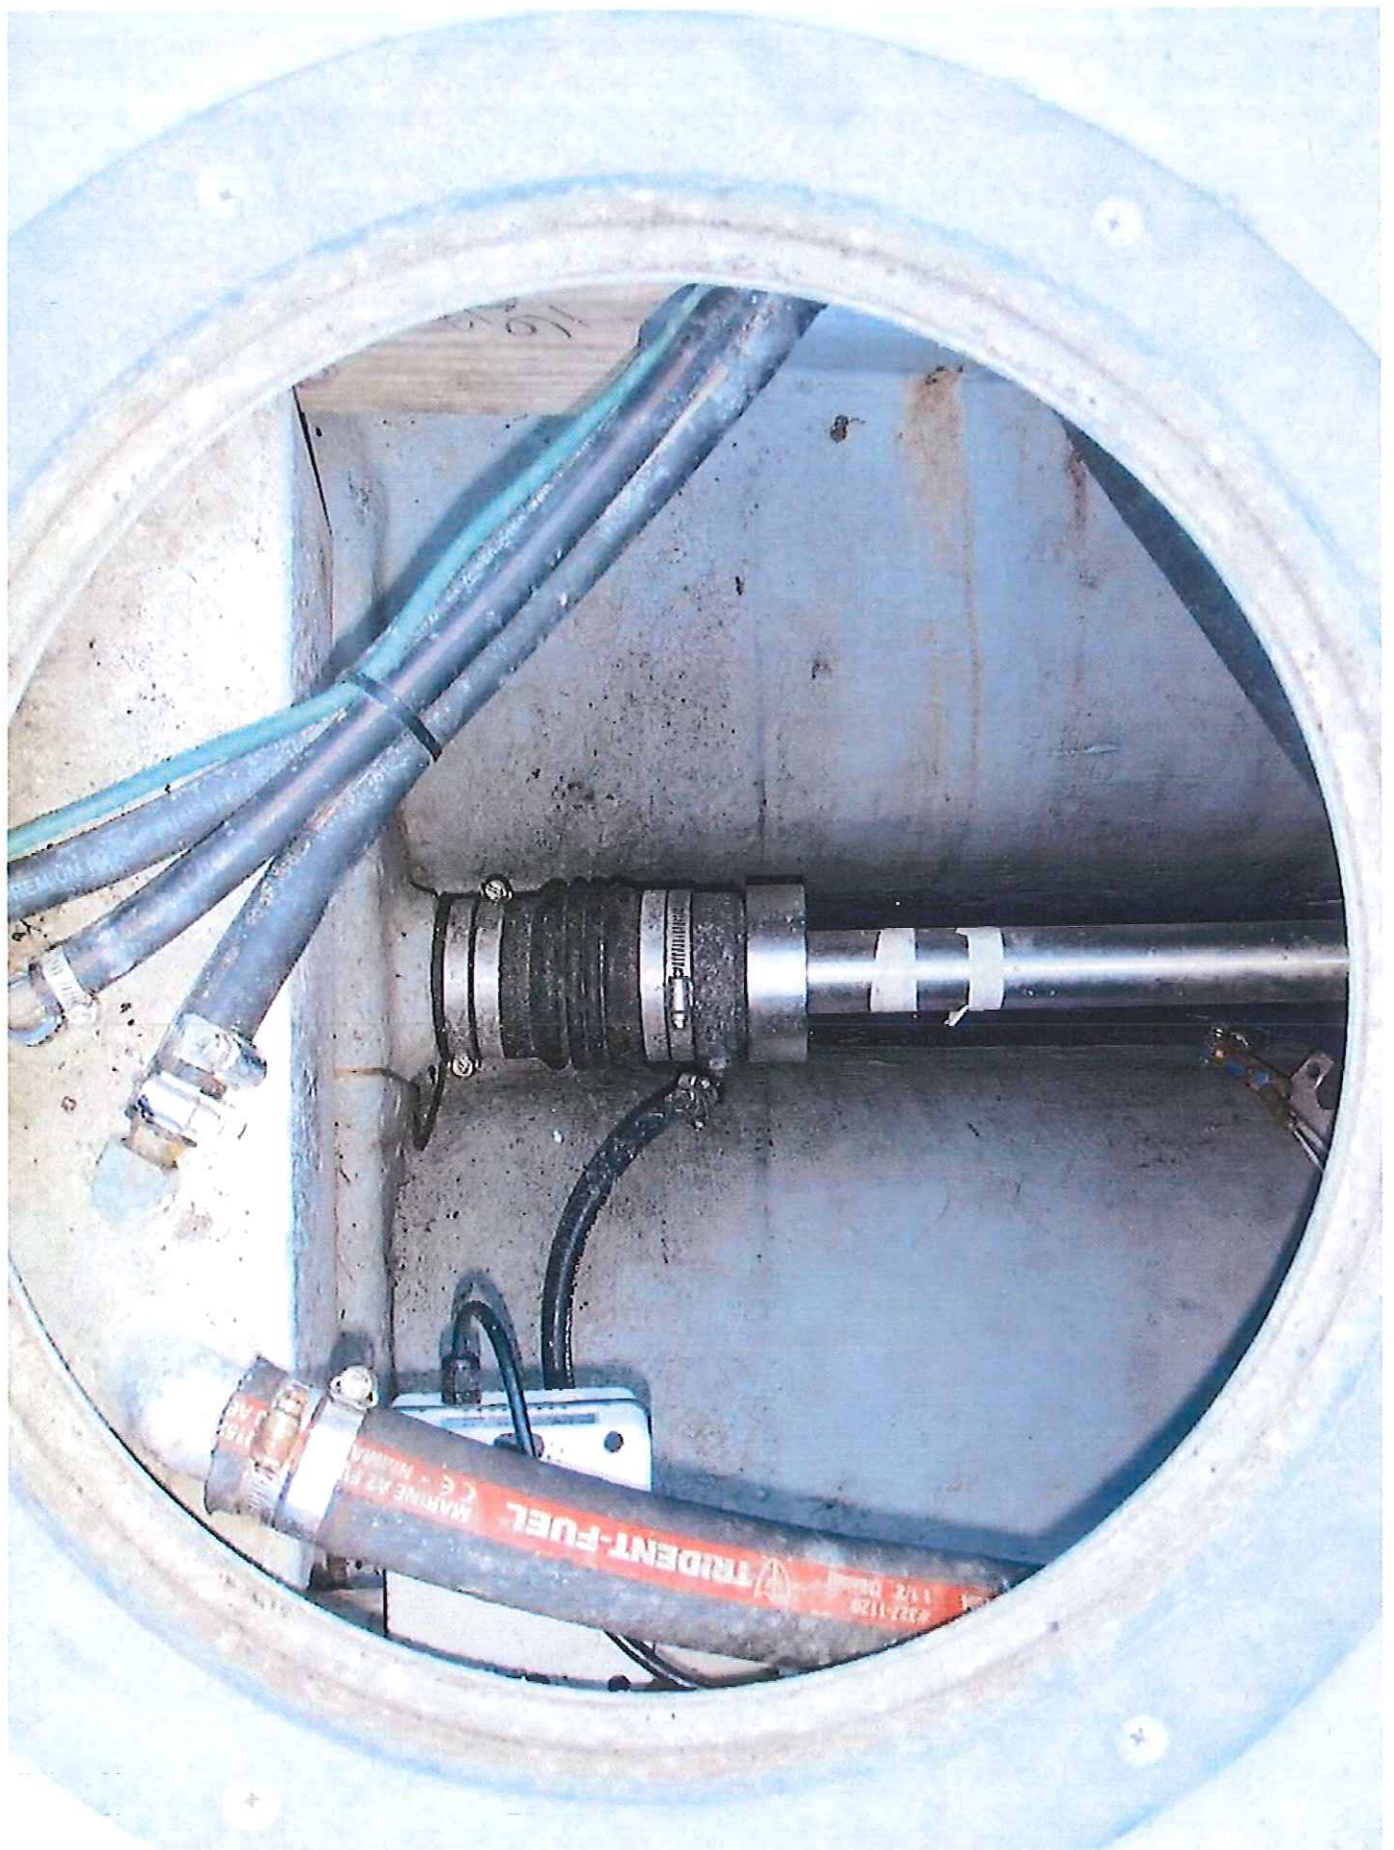
3

Loop in the crossover fuel line that should be eliminated to prevent a "water collection" area

Shut off valve should be added
